**DEPARTMENT OF TRANSPORTATION**

Contract #: 04-0120F4Cty: SF/ALA Rte: 80 PM: 13.2/13.9File #: 69.28**WELDING INSPECTION REPORT****Resident Engineer:** Pursell, Gary**Address:** 333 Burma Road**City:** Oakland, CA 94607**Report No:** WIR-007139**Date Inspected:** 20-May-2009**Project Name:** SAS Superstructure**OSM Arrival Time:** 1900**Prime Contractor:** American Bridge/Fluor Enterprises, a JV**OSM Departure Time:** 700**Contractor:** Zhenhua Port Machinery Company, Ltd (ZPMC), Changxing Island **Location:** Shanghai, China**CWI Name:** See Below**CWI Present:** Yes No**Inspected CWI report:** Yes No N/A**Rod Oven in Use:** Yes No N/A**Electrode to specification:** Yes No N/A**Weld Procedures Followed:** Yes No N/A**Qualified Welders:** Yes No N/A**Verified Joint Fit-up:** Yes No N/A**Approved Drawings:** Yes No N/A**Approved WPS:** Yes No N/A**Delayed / Cancelled:** Yes No N/A**Bridge No:** 34-0006**Component:** OBG and Tower Fabrication**Summary of Items Observed:**

## WELDING INSPECTION REPORT

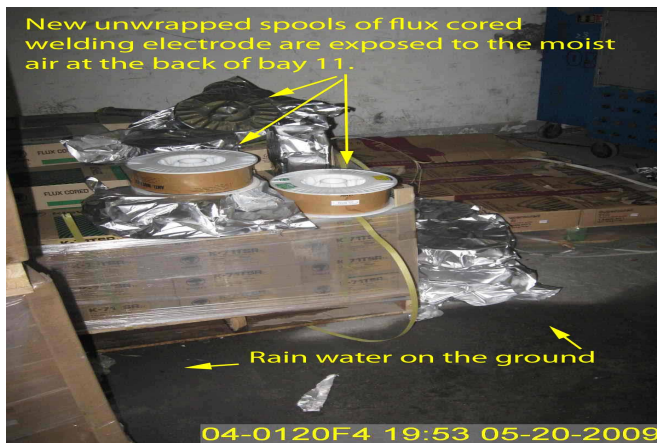
This QA Inspector performed random visual inspection of the flux cored welding electrode storage location in near the back of heavy tower bay #11 where a small amount of rainwater had run inside the building. The QA Inspector observed ZPMC has three rolls of flux cored welding electrode which had been removed from the boxes and each of them had the air tight protective cover removed from the spool of electrode material. The QA Inspector informed ABF and QC personnel this type of electrode should remain in the hermetically sealed packaging until this material is ready for use, and this welding electrode was discarded. Note: AWS D1.5 paragraph 12.6.7.2 states: "Electrode Packaging. FCAW and GMAW (metal cored) electrodes shall be received in moisture-resistant packages that are undamaged. They shall be protected against contamination and injury during shipment and storage. Electrode packages shall remain effectively sealed against moisture until the electrode is required for use." ZPMC QC representative Mr. Zu Jin Long informed this QA Inspector the three spools of welding electrode will not be used for welding and they will be put into the trash container. See the photograph below for additional information.
